Environmental Report

24 Commerce Drive, Monroe

Date: February 23, 2022

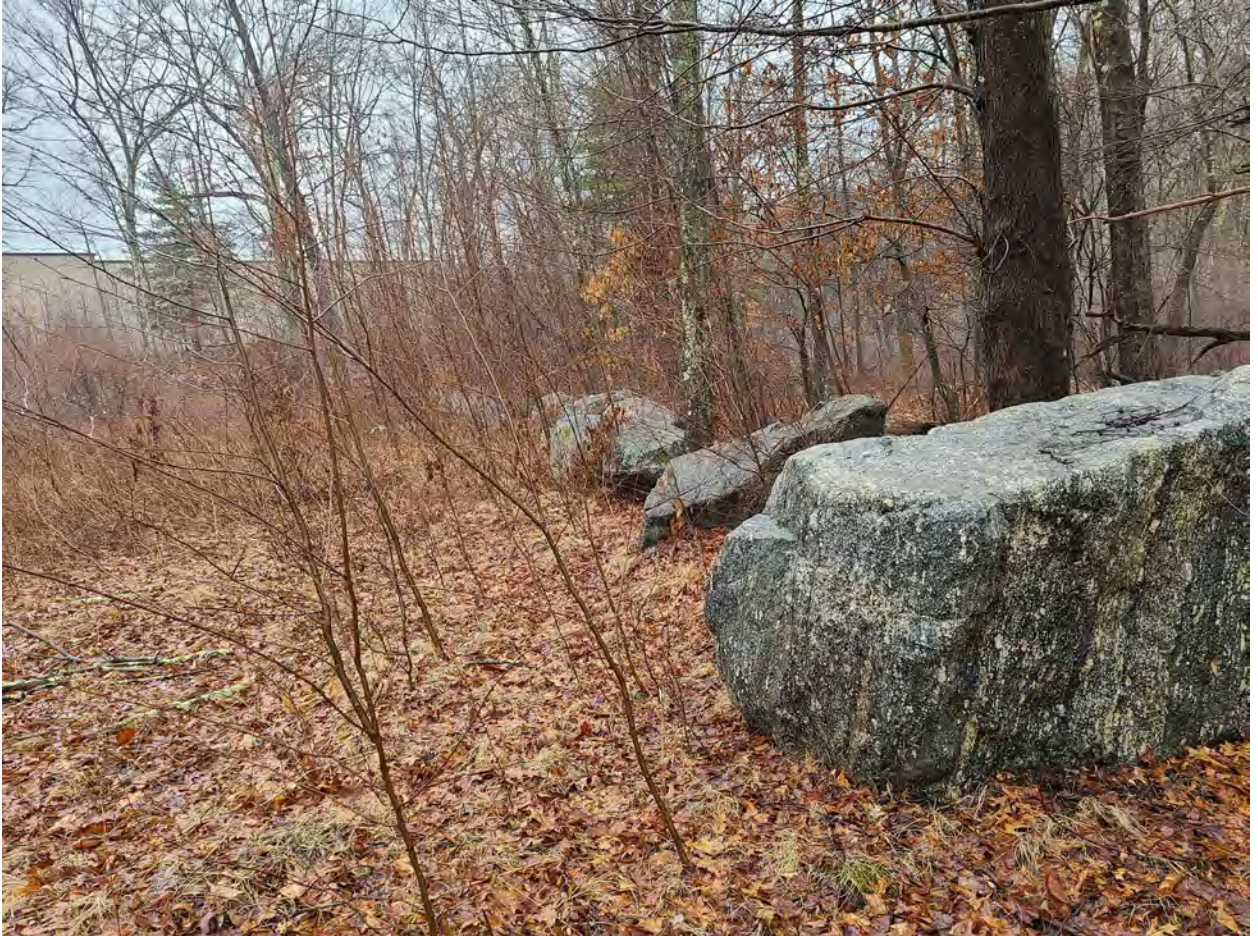
Photo 1. Line of Boulders: separating proposed parking in disturbed area (left of boulders) from the natural wetland buffer (right of boulders), looking north. **2/23/22.**

A line of boulders, placed previously, separates the forested floodplain and its relatively natural upland buffer from the previously disturbed region of the site where the proposed activity will occur.

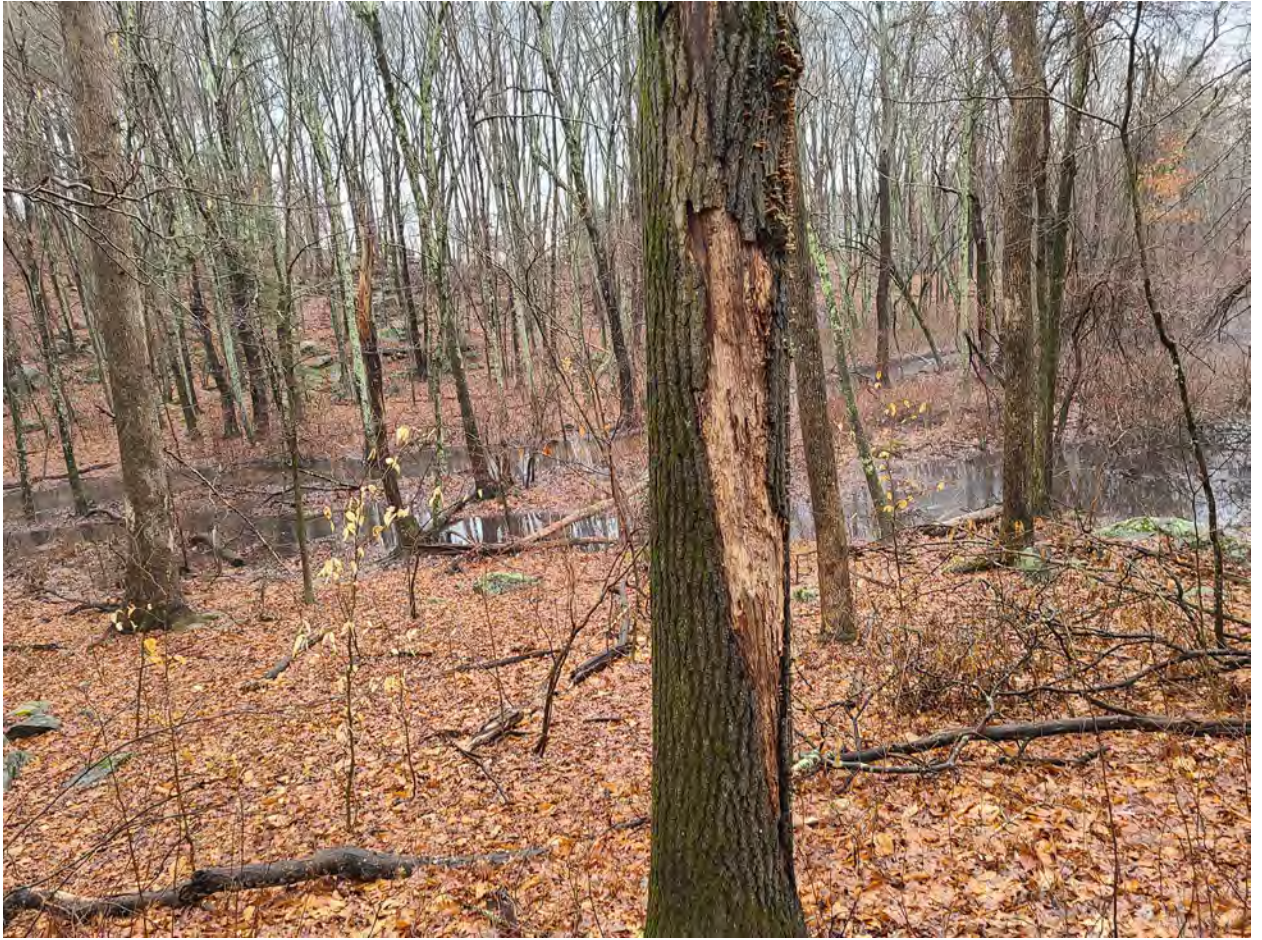
Photo 2. River and floodplain: northeast region of site, looking east. **2/23/22.**

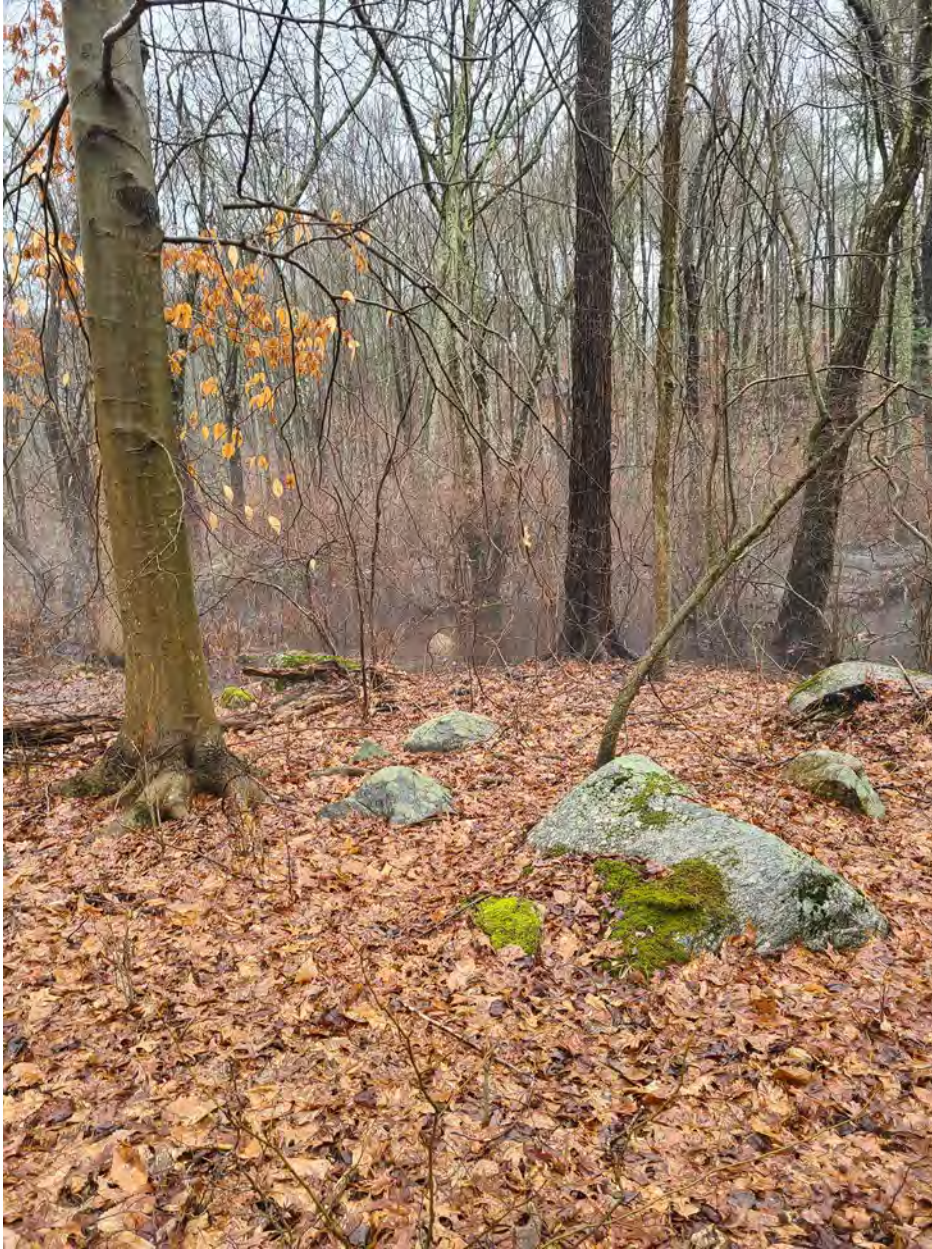
Photo 3. River and floodplain: Looking east. 2/23/22.

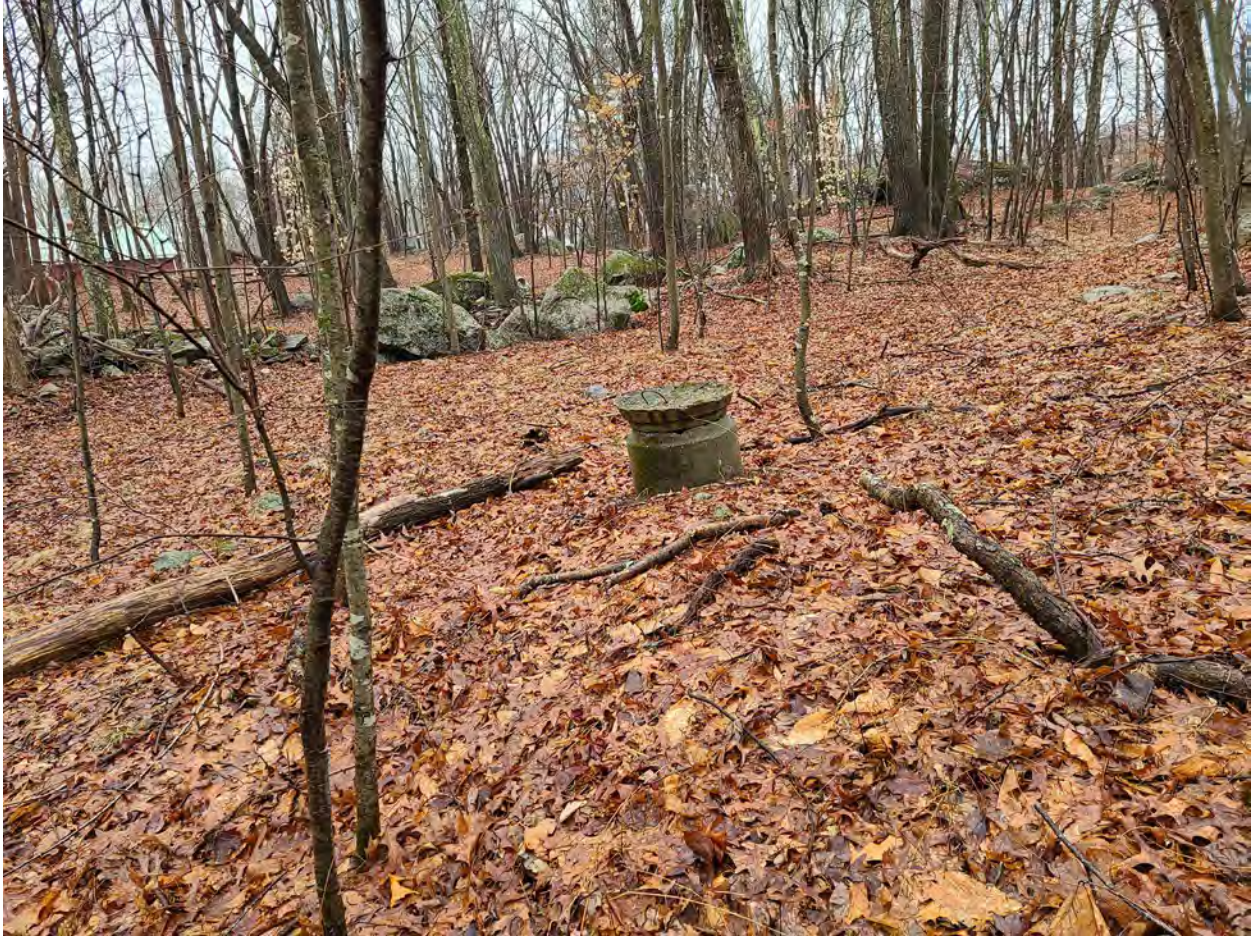
Photo 4. Upland buffer to floodplain: Site of old well and historically disturbed soils. Southeast region of site, looking west (back to wetlands) **2/23/22.**

- Although the wetland buffer east of the existing line of boulders/proposed wall is currently mainly in a natural state, it should be noted that a well still exists in the southern corner of this area. The wetland buffer around the well has been previously disturbed due to the water line (as per the photo at the end of this report).
